REPORT

UltraTEV Monitor Analysis for RESPOND Project

Prepared for: ENWL

Project No: T8214
Document Version: Issue 1.1
Date: 16 October 2017

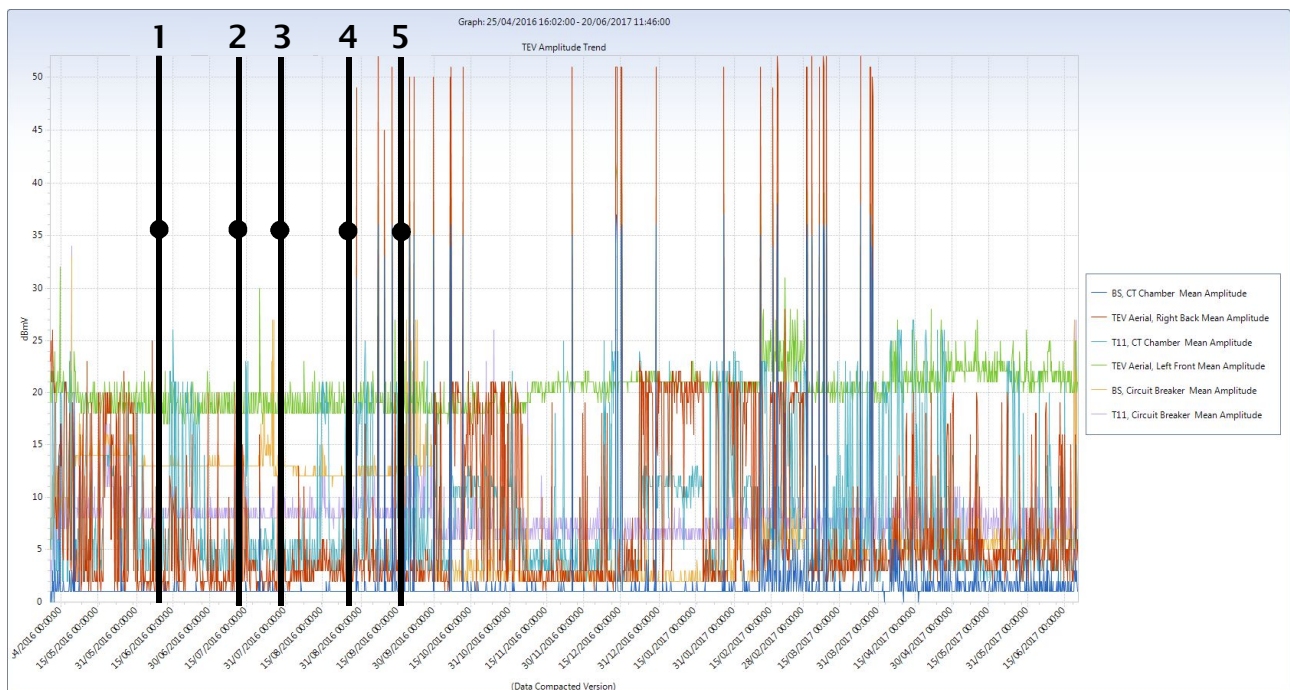
An UltraTEV Monitoring system with 4 nodes was installed in Atherton Town Centre substation and monitored activity in the substation between 25/04/2016 to 20/06/2017. Figure 1 below is a plot containing all the TEV activity captured from Atherton Town Centre substation. Elevated TEV activity was detected on all channels. The patterns mostly correlated to measurements from the aerials, which suggest that the source is external interference. Five faults occurred during this monitoring period, where the date is shown as an overlay on Figure 1. The date and brief information of five incidents are the following:

Figure 1 TEV Activity Plot with Date of Faults Overlay for All TEV Channels in Atherton Town Centre

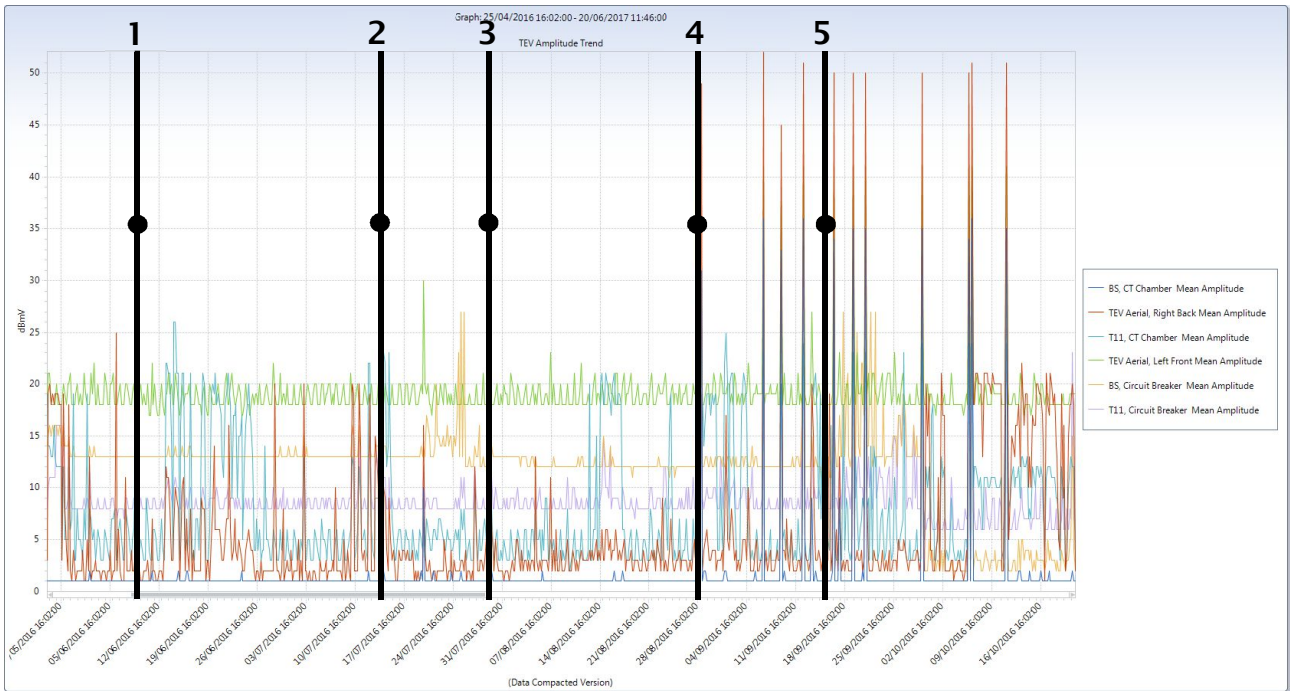
Figure 2 TEV Activity Plot for All TEV Channels in Atherton Town Centre between 05/06/2016 to 16/10/2016

Figure 2 above illustrates TEV activity captured on all channels in Atherton Town Centre substation between the period of 05/06/2016 to 16/10/2016, which covers all the faults that occurred in this substation. According to the activity shown in Figure 2, the faults on five occasions did not significantly affect the TEV magnitude or patterns observed from all six channels. The base level of TEV activity stayed at a similar level prior to and after the fault occurred. Respond FLM was engaged on fault number 3, 4, and 5, yet, the TEV activity remained similar after the engagement of the equipment. Figure 3 and Figure 4 below are a six-week close-up of TEV activity covering the occurrence of fault number 3, and number 5. The magnitude and pattern of TEV activity from these two figures remained the same despite three faults occurring between the two-time periods. Note that the multiple high amplitude spikes in Figure 4 were caused by external interference, as the most dominant signal came from the two aerials. This suggests that faults and the use of Respond FLM do not affect the TEV activity within these assets.

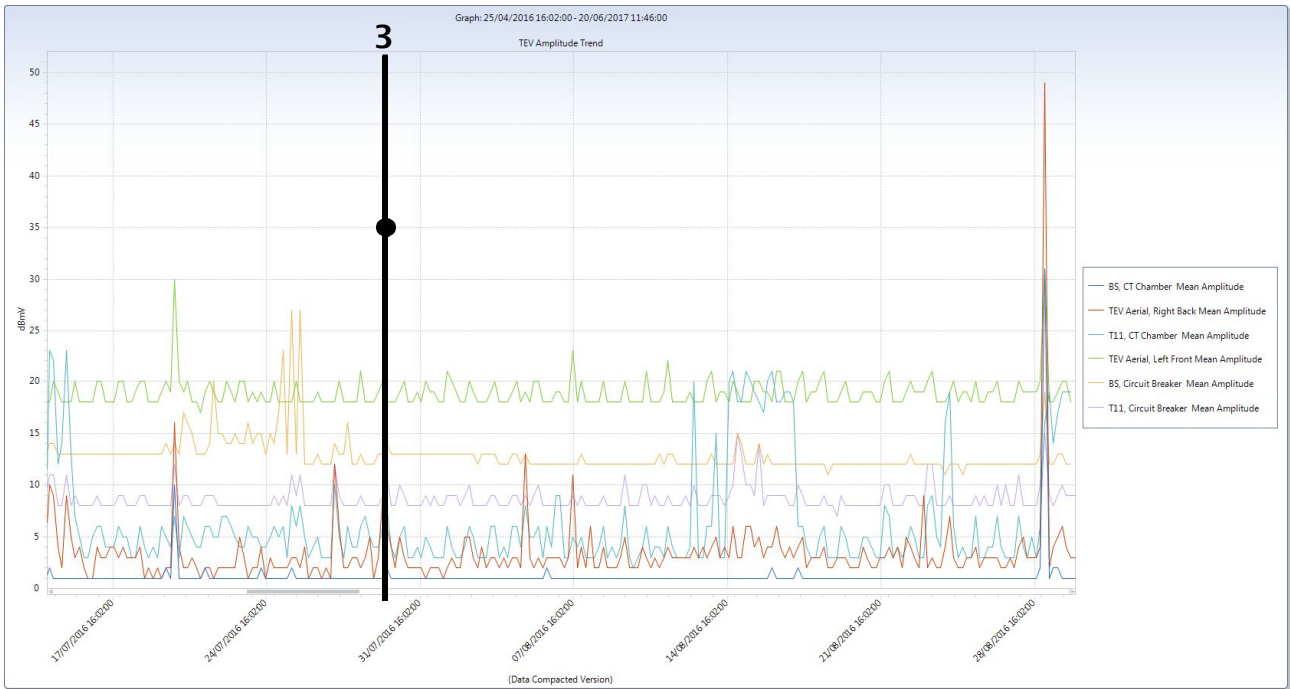
Figure 3 Close-Up of TEV Activity Plot for All TEV Channels in Atherton Town Centre Covering Fault Number 3

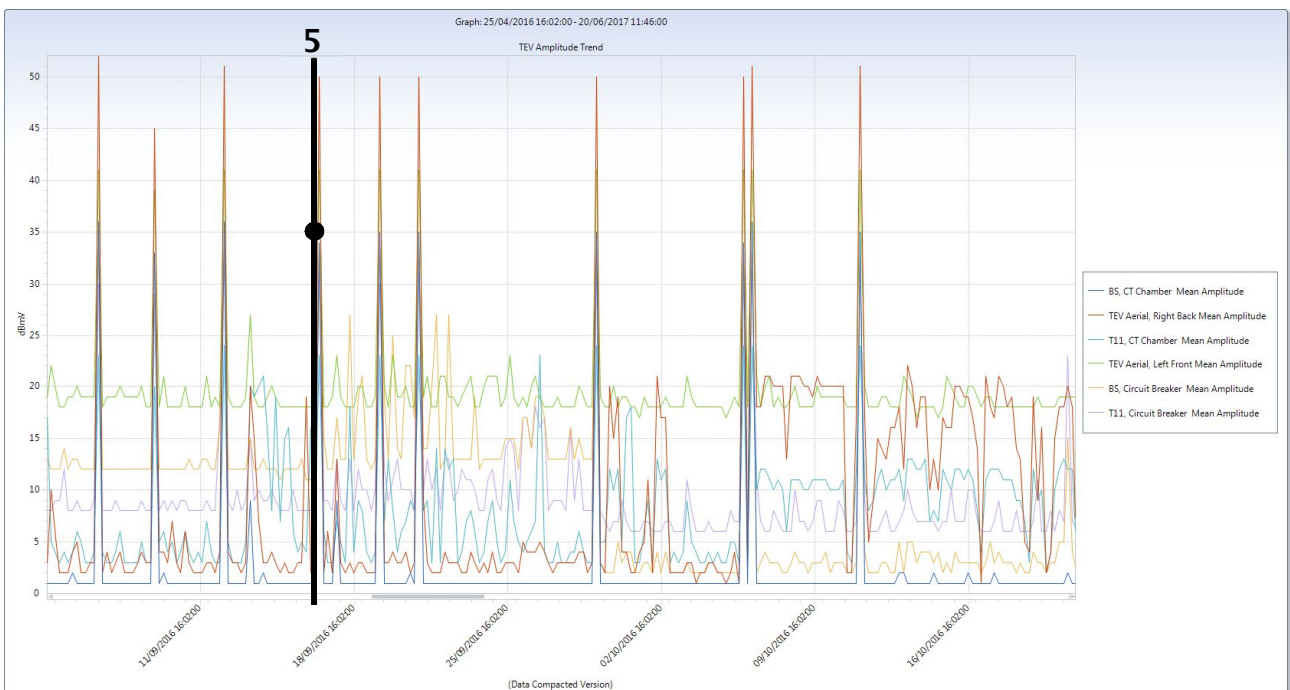
Figure 4 Close-Up of TEV Activity Plot for All TEV Channels in Atherton Town Centre Covering Fault Number 5

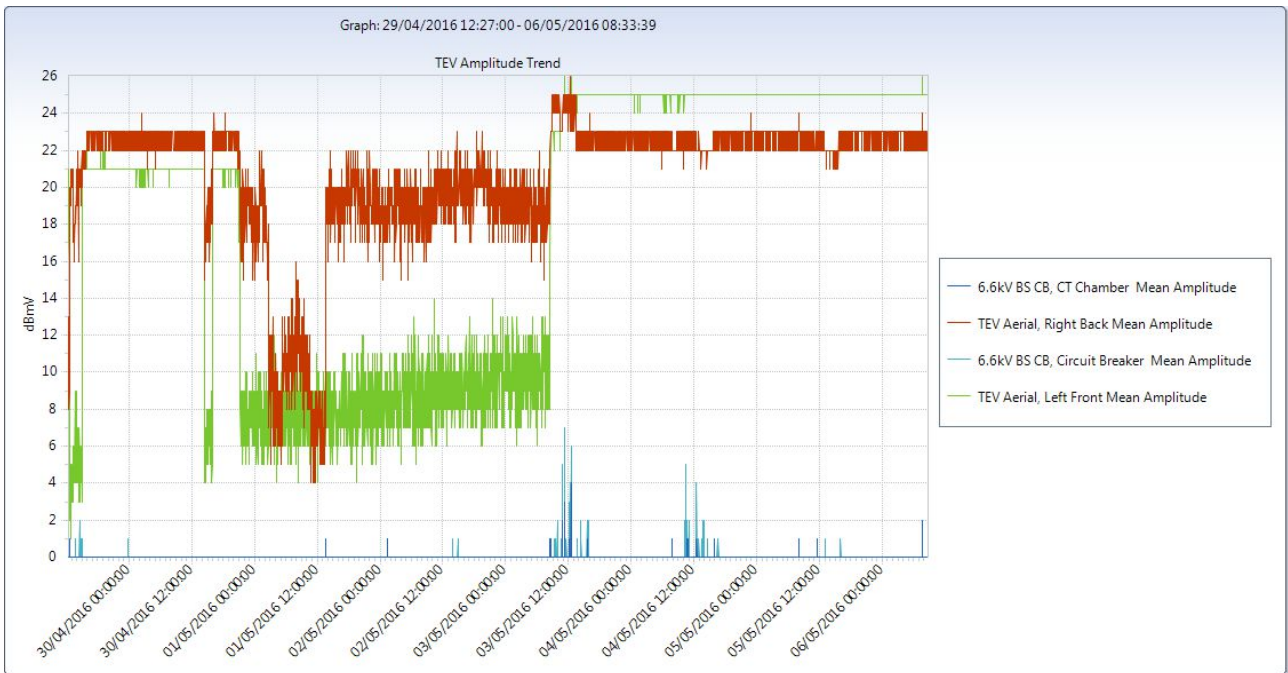
An UltraTEV Monitoring system with 2 nodes was installed in Blackbull substation and monitored activity in the substation between 29/04/2016 to 06/05/2016. Figure 5 illustrates captured TEV activity on all the channels in Blackbull substation. Activity captured from the two aerial channels dominated the TEV plot, and signals from the remaining channels are well below the PD threshold, which suggests that there was no partial discharge activity detectable in this session.

According to a fault log, there was a fault that occurred on 06/04/2017, however, the obtained data only captured activity between 29/04/2016 to 06/05/2016. Hence, the fault history of this substation cannot be correlated to the captured activity.

Figure 5 TEV Activity Plot for All Channels in Blackbull

- R1. An UltraTEV Monitor should be installed in Blackbull, and Offerton substations for at least one week after the completion of the project in order to monitor and trend TEV activity.
- R2. Should any faults occur, an UltraTEV Monitor should be installed in the Denton West, Irlam, and Mount St. substations to monitor and trend TEV activity.
- R3. The UltraTEV Monitor data from eight substations should be reviewed at the end of project, June 2018, to investigate the effects of faults and the engagement of Respond FLM equipment.

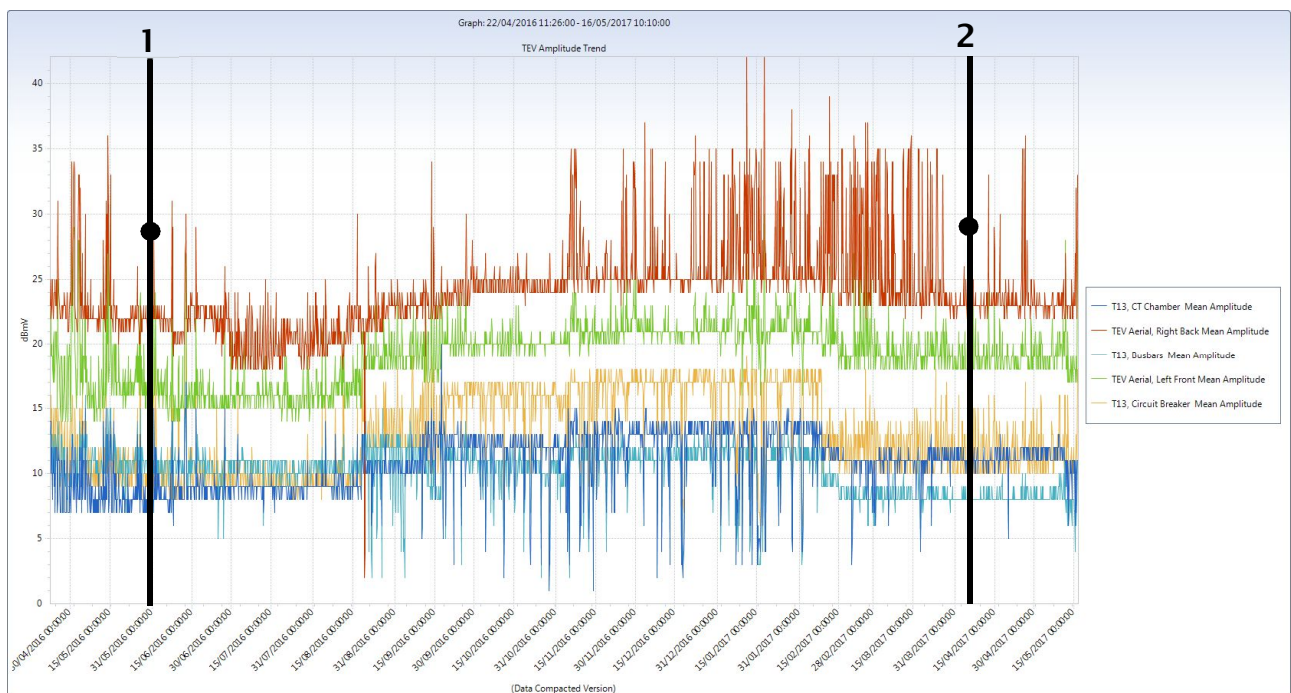
An UltraTEV Monitoring system with 3 nodes was installed in Broadheath substation and monitored activity in the substation between 22/04/2016 to 16/05/2017. Figure 6 displays all TEV activity captured from the monitoring session. Activity captured from the two aerial channels are the strongest in this session, and activity from the three remaining TEV channels have a pattern that follow signals from the aerials closely. This suggests that there was no partial discharge activity detectable during this measurement period.

Figure 6 TEV Activity Plot with Date of Fault overlay for All TEV Channels in Broadheath

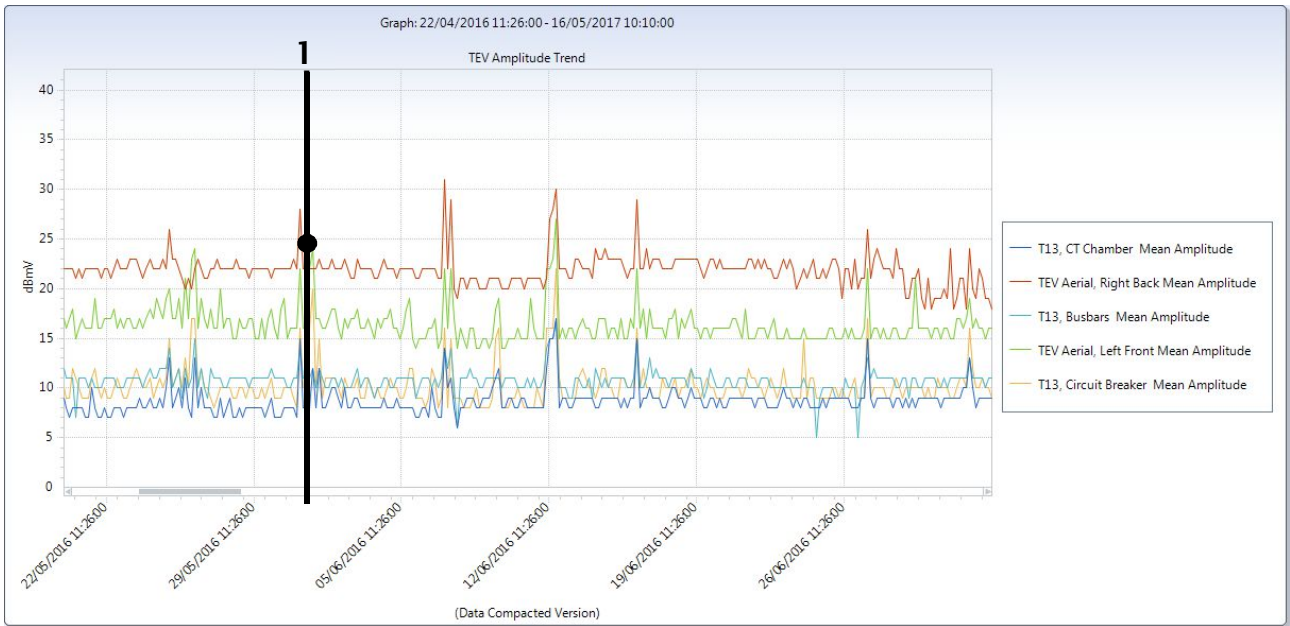
Figure 7 TEV Activity Plot with Date of Fault overlay for All TEV Channels Covering Fault Number 1

From the two diagrams above, there is no change of base level for TEV activity before or after the date of the incidents. Additionally, despite the occurrence of multiple faults, TEV activity still follows interference captured from the aerials. These confirm that; only external interference was captured on this measurement, and the faults had no effects on TEV activity.

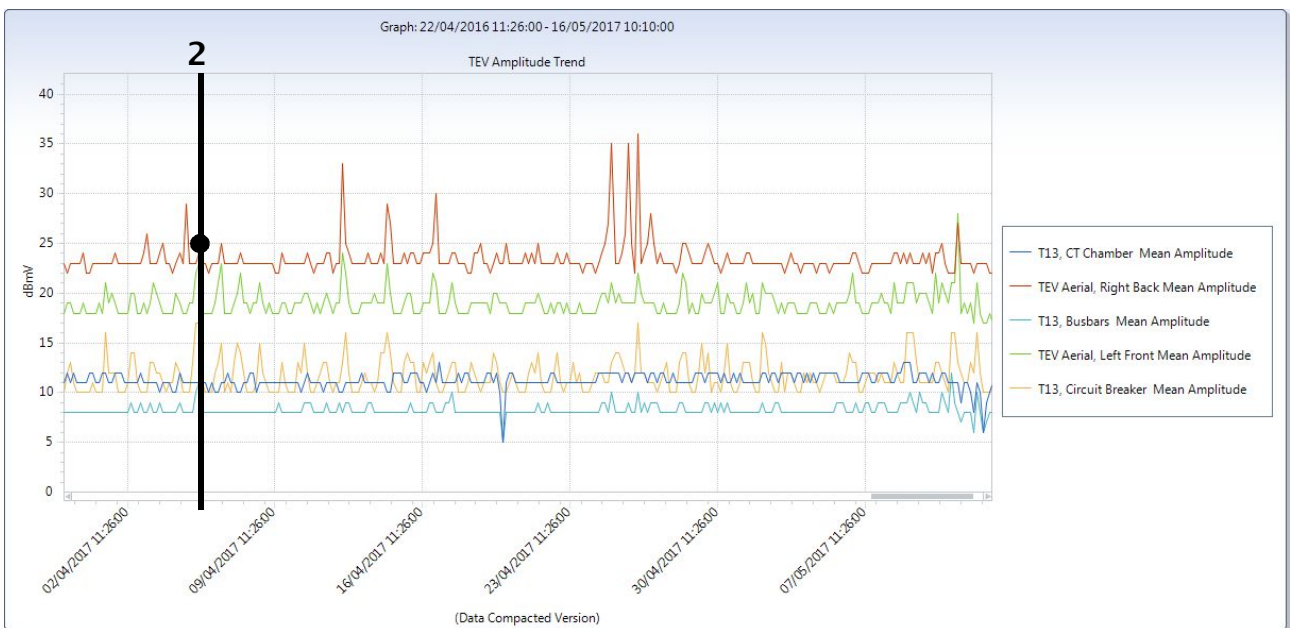
Figure 8 TEV Activity Plot with Date of Fault overlay for All TEV Channels Covering Fault Number 2

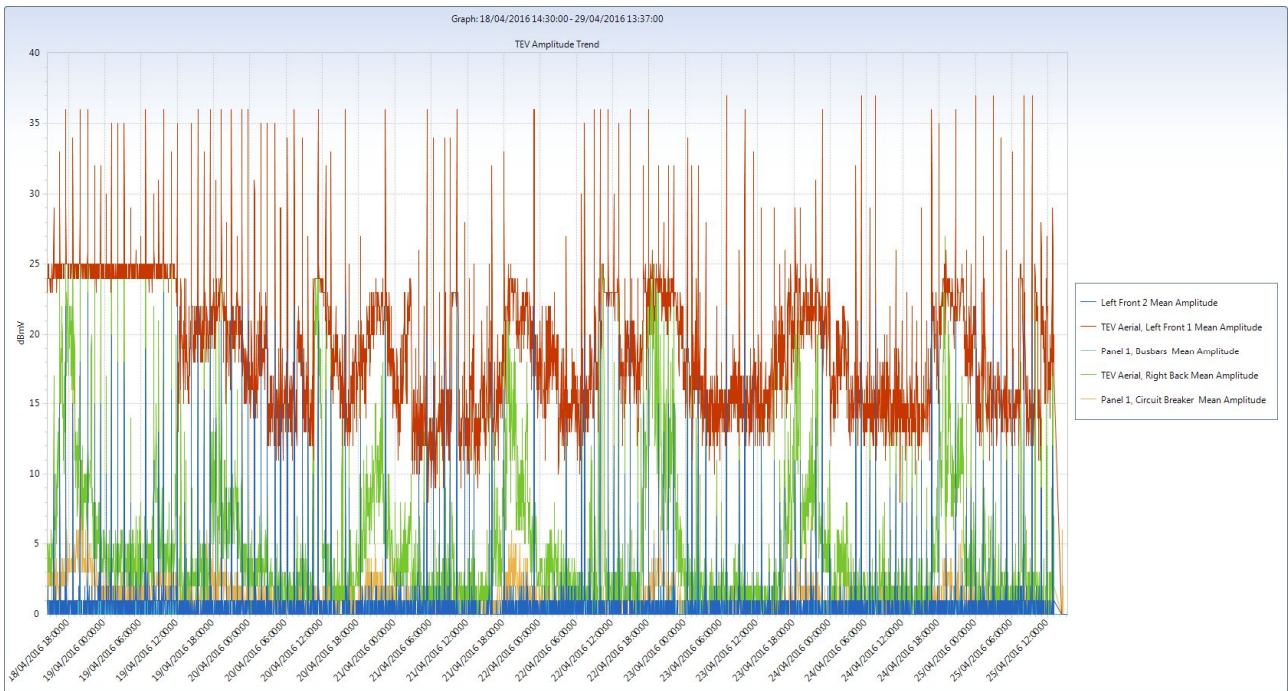
An UltraTEV Monitoring system with 3 nodes was installed in Denton West substation and monitored activity in the substation between 18/04/2016 to 29/04/2016. Figure 9 illustrates all TEV activity captured during the monitoring session. The most dominant activity captured in this session are from the two aerials, and the activity on the remaining TEV channels have patterns that are following closely throughout the period. Hence, it is reasonable to conclude that no partial discharge activity was detected in this session.

Figure 9 TEV Activity Plot for All TEV Channels in Denton West

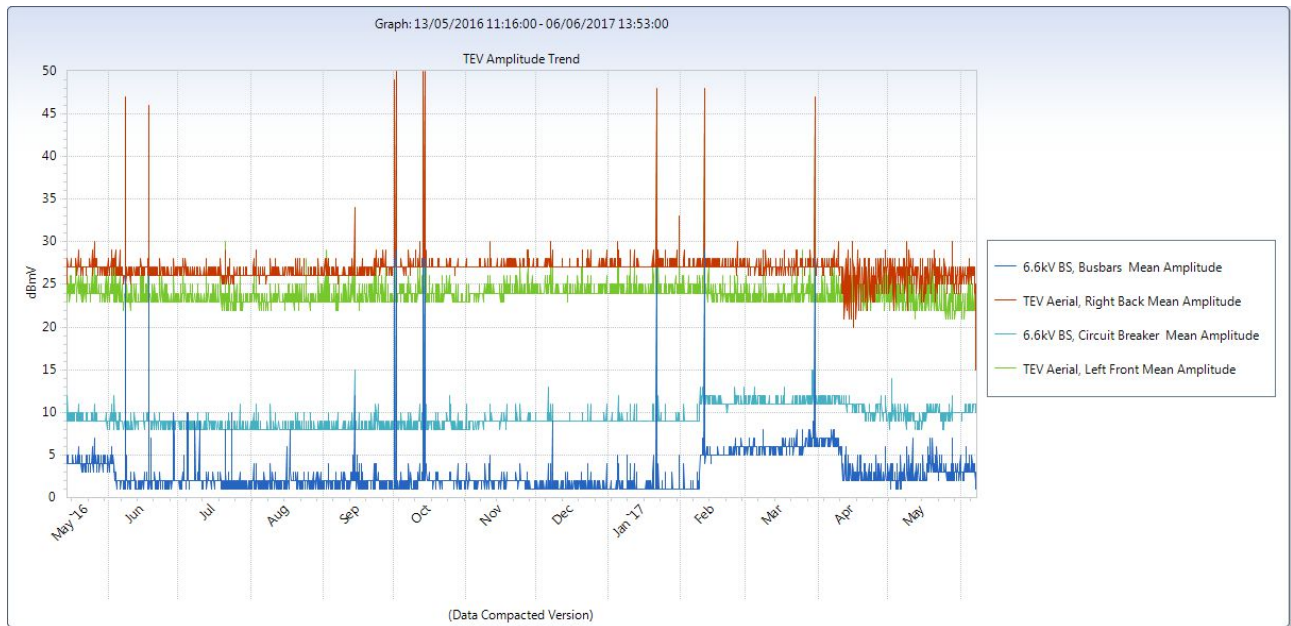
An UltraTEV Monitoring system with 2 nodes was installed in Irlam substation and monitored activity in the substation between 13/05/2016 to 06/06/2017. Figure 10 displays all TEV activity captured in Irlam substation. In this period, activity captured from the two aerial channels are the most dominant, and the activity from the remaining TEV channels follow the pattern of the aerials closely. Hence, it is reasonable to conclude that external interference is the main cause of all the captured activity, and no partial discharge activity was detected.

Figure 10 TEV Activity Plot for All TEV Channels in Irlam

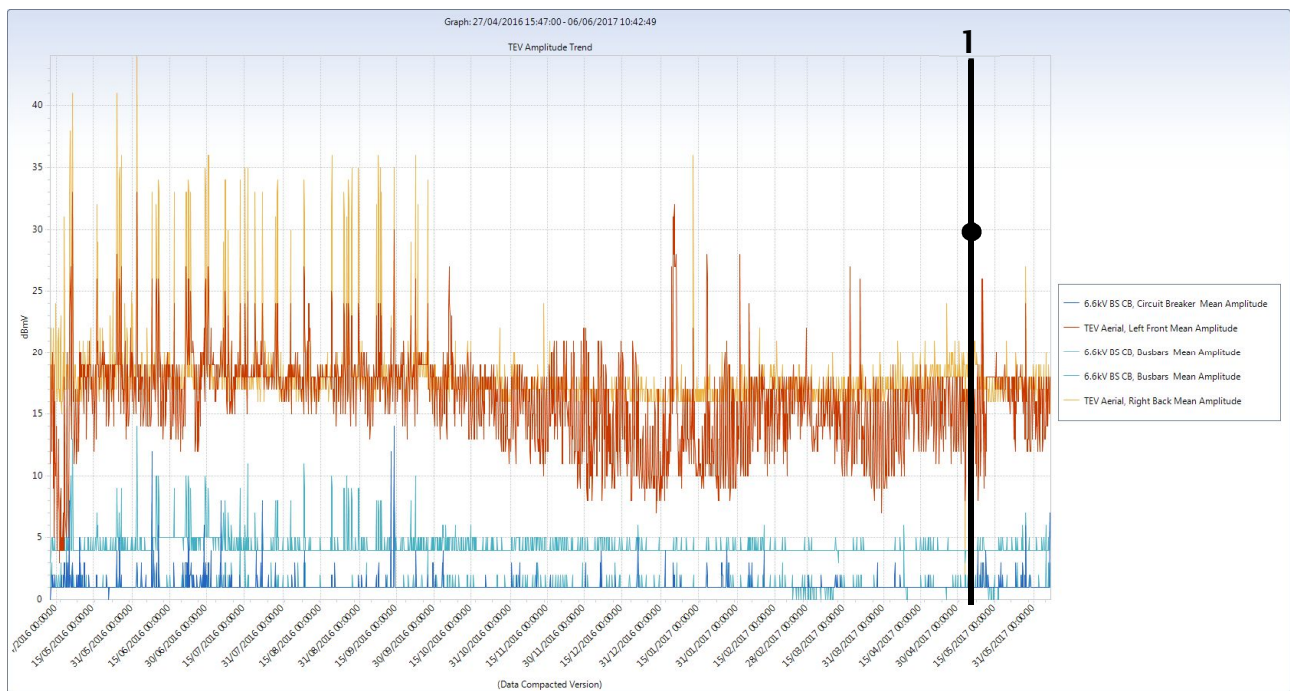
An UltraTEV Monitoring system with 3 nodes was installed in Littleborough substation and monitored activity in the substation between 27/04/2016 to 06/06/2017. Figure 11 displays all TEV activities captured in Littleborough substation. In this period, activity captured from the two aerial channels was the most dominant, and the activity from the remaining TEV channels remained dormant with minimal elevation below the signals from the aerials. This suggests that external interference caused the captured activity, and no partial discharge activity was detected.

A fault occurred in Littleborough substation on MIDGEHOLES/DEARNLEY feeder on 08/05/2017, and the Respond FLM equipment was engaged. An overlay is placed on Figure 11 to indicate the date of incident.

Figure 11 TEV Activity Plot for All TEV Channels in Littleborough

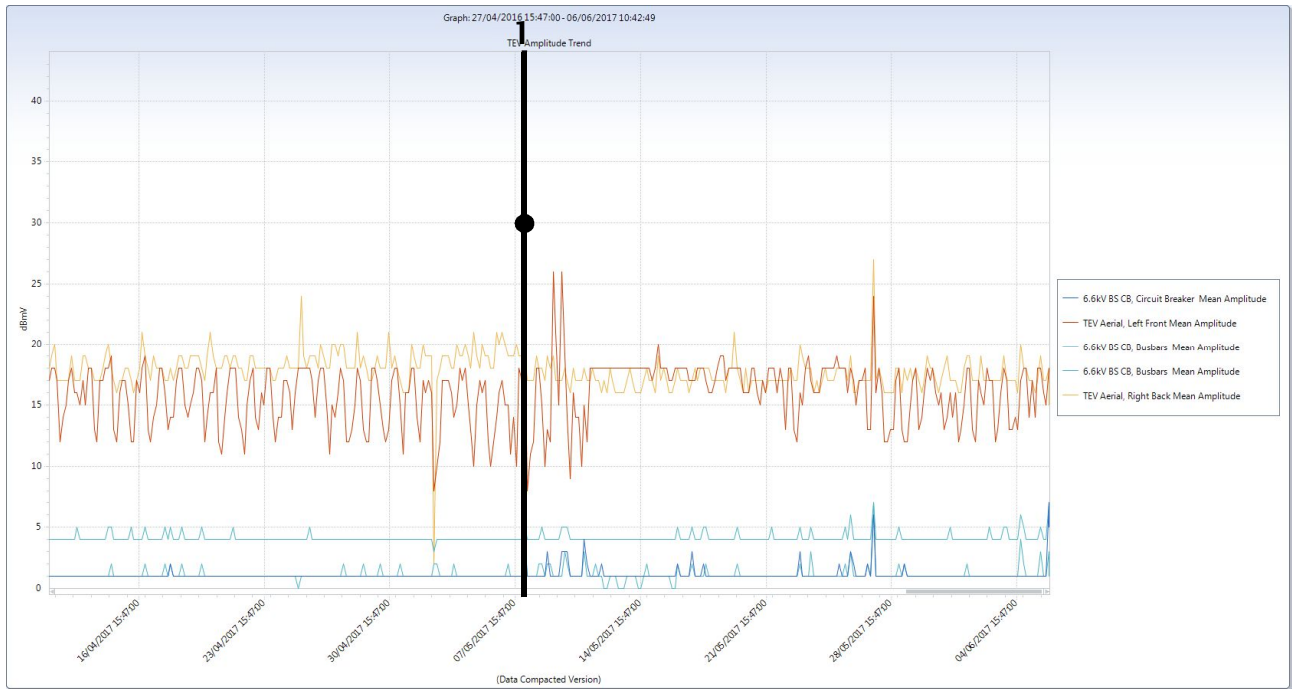
Figure 12 below displays a close-up of TEV activity in all channels two weeks before the date of the incidents, and four weeks after to capture TEV activity after the re-energization of assets. According to Figure 12, TEV activity remained at a similar level both before and after the fault. Furthermore, there is no change in the pattern of activity in any of the channels. This suggests that the faults and the engagement of Respond FLM equipment did not affect TEV activity in terms of magnitude and patterns. This also confirms that only external interference was detectable during this monitoring session, and no partial discharge activity was detected.

Figure 12 TEV Activity Plot with Date of Fault overlay for All TEV Channels Covering Fault in Littleborough

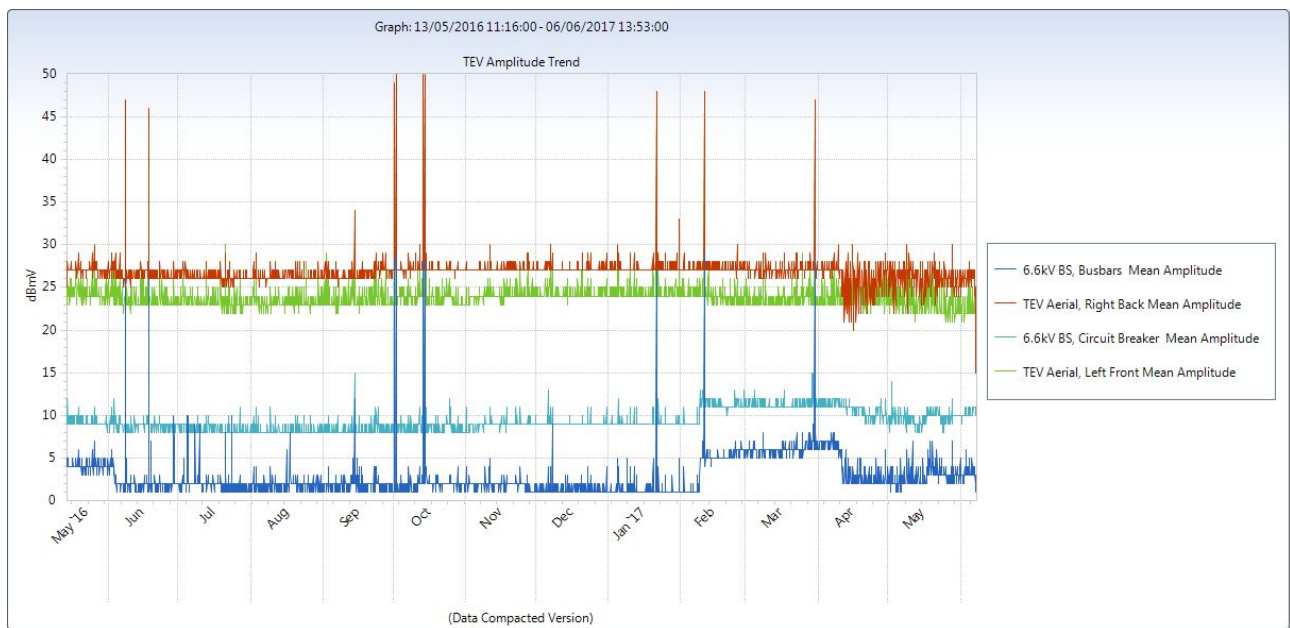
An UltraTEV Monitoring system with 3 nodes was installed in Mount St substation and monitored activity in the substation between 06/05/2016 to 13/05/2016. Figure 13 illustrates all the captured TEV activity in Mount St substation. During this monitoring session, the activity captured from the two aerial channels had the strongest magnitude. Additionally, activity in the remaining TEV channels had patterns that followed closely to the pattern of aerials. Hence, it is reasonable to conclude that external interference is the main cause of all the captured activity, and no partial discharge activity was detected during this measurement period.

Figure 13 TEV Activity Plot for All TEV Channels in Mount St

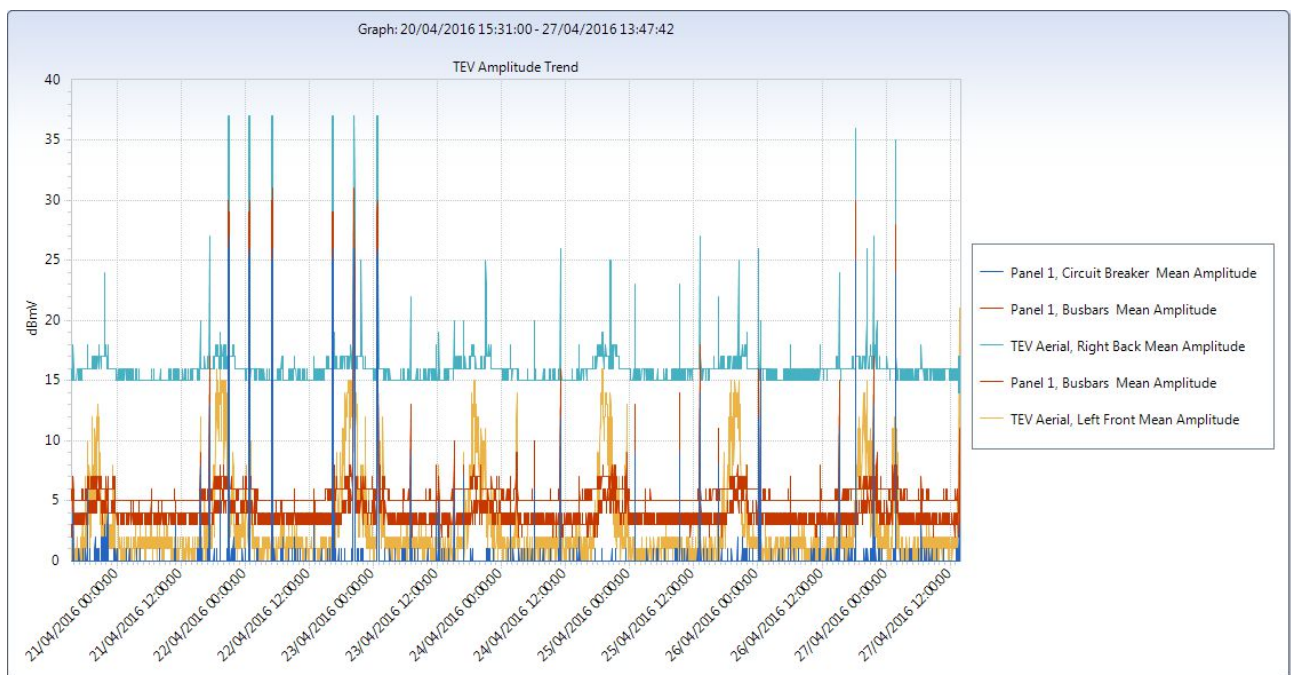
An UltraTEV Monitoring system with 2 nodes was installed in Offerton substation and monitored activity in the substation between 20/04/2016 to 27/04/2016. Figure 14 illustrates all the captured TEV activity in Offerton substation. During this monitoring session, the activity captured from the TEV Aerial, Right Back exhibited a pattern with the strongest magnitude. Additionally, activity in the remaining TEV channels had patterns that followed closely to the pattern of the aerials. Hence, it is reasonable to conclude that external interference is the main cause of all the captured activity, and no partial discharge activity was detected during this measurement period.

According to a fault log, a fault occurred on 14/06/2016, however the obtained data only captured activity between 20/04/2016 to 27/04/2016. Hence, fault history of this substation cannot be correlated to the captured activity.

Figure 14 TEV Activity Plot for All TEV Channels in Offerton
