REPORT N° 62104988

RESPOND POST FAULT ANALYSIS

26 JUNE 2017

Electricity North West Ltd

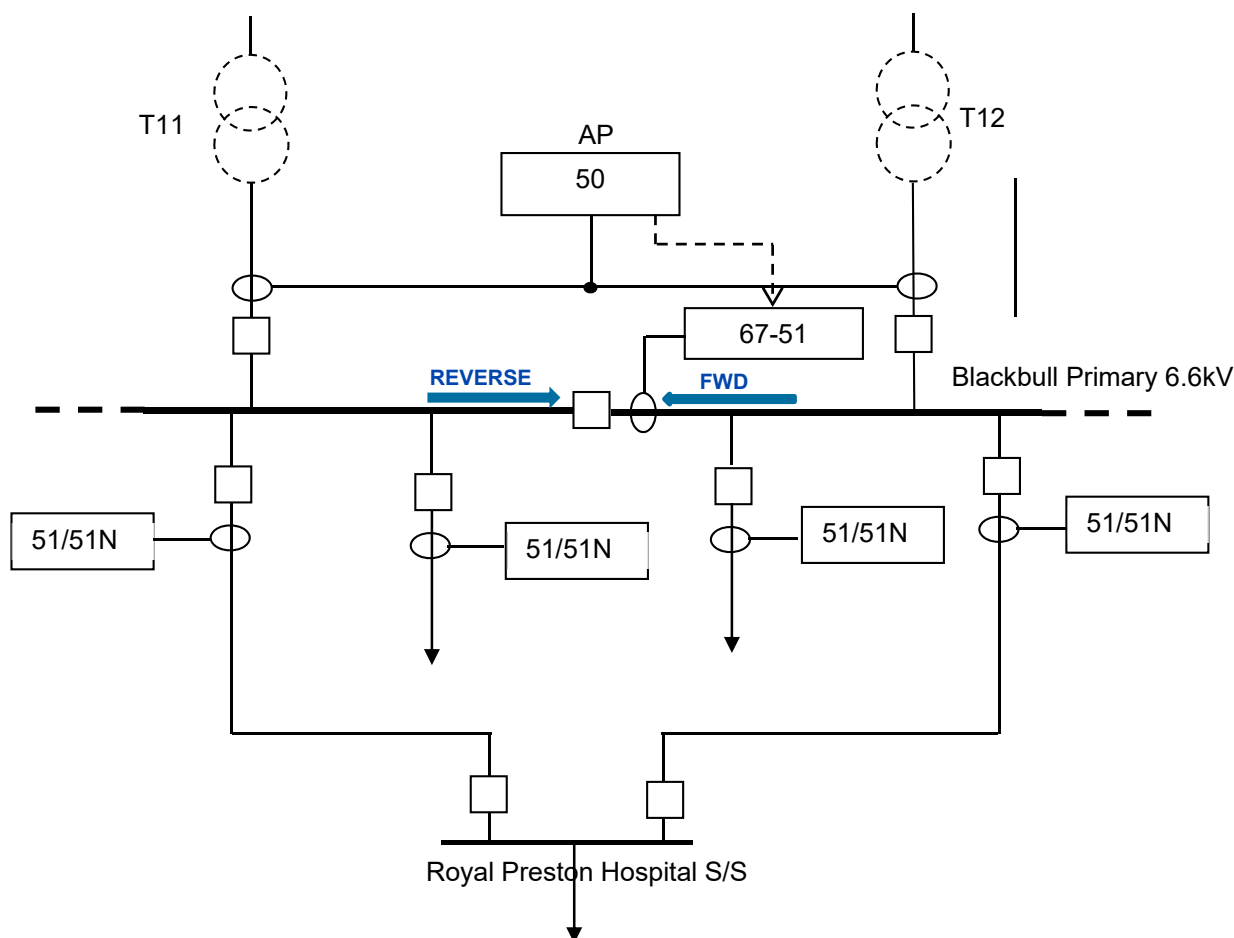
Figure 3-1: Blackbull Primary Network

The pre-fault Blackbull Primary substation configuration is shown in Figure 3.1. Note: The feeders to the Royal Preston Hospital substation form a closed ring.
