REPORT N° 62104988

RESPOND POST FAULT ANALYSIS

Electricity North West Ltd

Substation	Irlam Primary
Fault Mitigation Technique	Adaptive Protection
Voltage	6.6 kV
Date/Time	17 August 2017 / 00.12.32
Faulted Circuit	F3145 Tramway Rd 6.6 kV circuit
Fault Location	At GVR 7269 Astley Rd - between Whittle St and Starring Way

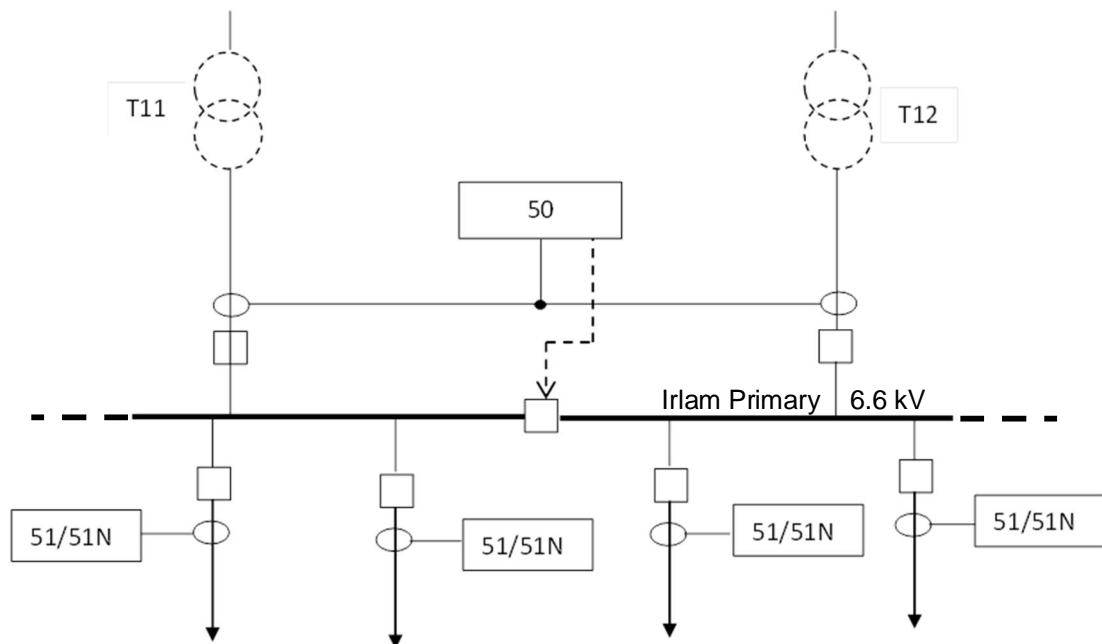
Figure 3-1: Irlam Primary Substation Network

The pre-fault Irlam Primary network configuration is shown in Figure 3-1. For the Respond trials, the 6.6 kV transformer incomer CTs are connected in parallel. The individual phase current inputs to the Adaptive Protection high-set instantaneous overcurrent relay (50) receives the sum of the respective phase currents in each transformer incomer. Operation of the Adaptive Protection initiates the tripping of the 6.6 kV bus section circuit breaker, increasing the impedance to the fault and reducing the initial fault current.

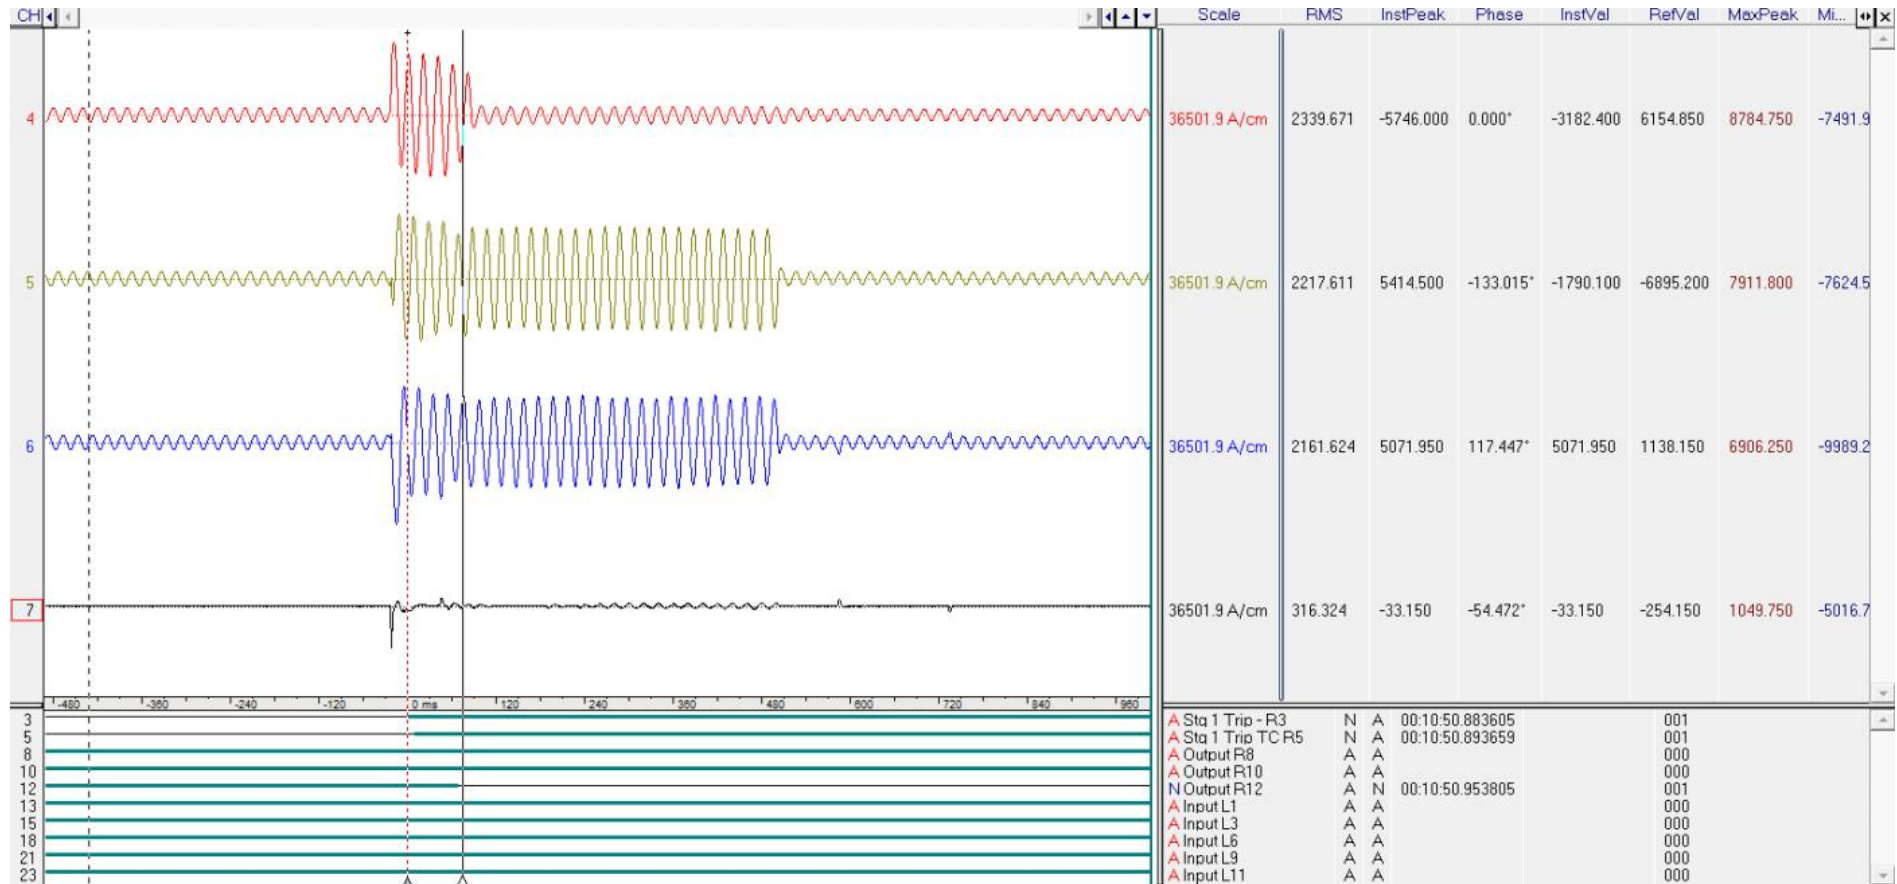
Figure 4-1: Instantaneous Adaptive Protection Relay Recordings (IA=red, IB=yellow, IC=blue and IN(residual)=black)

The instantaneous and RMS disturbance records obtained from the Adaptive Protection relay are shown in Figure 4-1 and Figure 4-2 respectively.

In these figures, Output R3 is the trip signal from the Adaptive Protection Stage 1 to the 6.6 kV bus section circuit breaker, output R5 is the Adaptive Protection Stage 1 trip repeat signal to telecontrol and output R12 is the bus section circuit breaker "a" auxiliary contact repeat signal to telecontrol.

The disturbance records show that the Adaptive Protection responded to a three-phase to earth fault. The magnitude of the fault currents inclusive of load current at the instant that the Adaptive Protection operated, were 5656 A, 4363 A and 6083 A in the red, yellow and blue phases respectively. The residual fault current was 1459 A.

The three-phase to earth fault was present for 22.1 ms before the Adaptive Protection was triggered. In this case the fault current was only a multiple of 1.36 times the Adaptive Protection I>3 current setting. For fault currents greater than a multiple of 2 times the current settings, the detection time should be less.

The disturbance record shows that the 6.6 kV bus section circuit breaker tripped 69.8 ms after the trip signal from the Adaptive Protection relay was sent. This time is largely dependent on the circuit breaker operating time and would not change with fault current. Note: The event times from the CRMS suggest that the 6.6 kV bus section circuit breaker tripped 36 ms after the Adaptive Protection relay operated. Since a circuit breaker operating time is typically 70 ms, it is judged that the time between the Adaptive Protection alarm and CB opening as indicated by the CRMS is too short. The discrepancy between the disturbance recorder time and the CRMS time is probably due to the low time resolution of the CRMS recordings.

The time interval from fault initiation up to the tripping of the 6.6 kV bus section circuit breaker was 91.9 ms measured from the disturbance record.

After the 6.6 kV bus section circuit breaker tripped, the fault developed into a yellow to blue phase-to-phase fault with 725 A in the red phase, 4341 A in the yellow phase and 3848 A in the blue phase with a residual current of 81 A.

In order to capture the opening of feeder circuit breakers with longer protection operating times, it is recommended that the total recording time is increased to 2.0 secs with the same pre-trigger recording time of 0.5 secs. The recommended relay setting parameters are as follows:

Duration = 2.0 secs

Trigger Position = 25 (%)

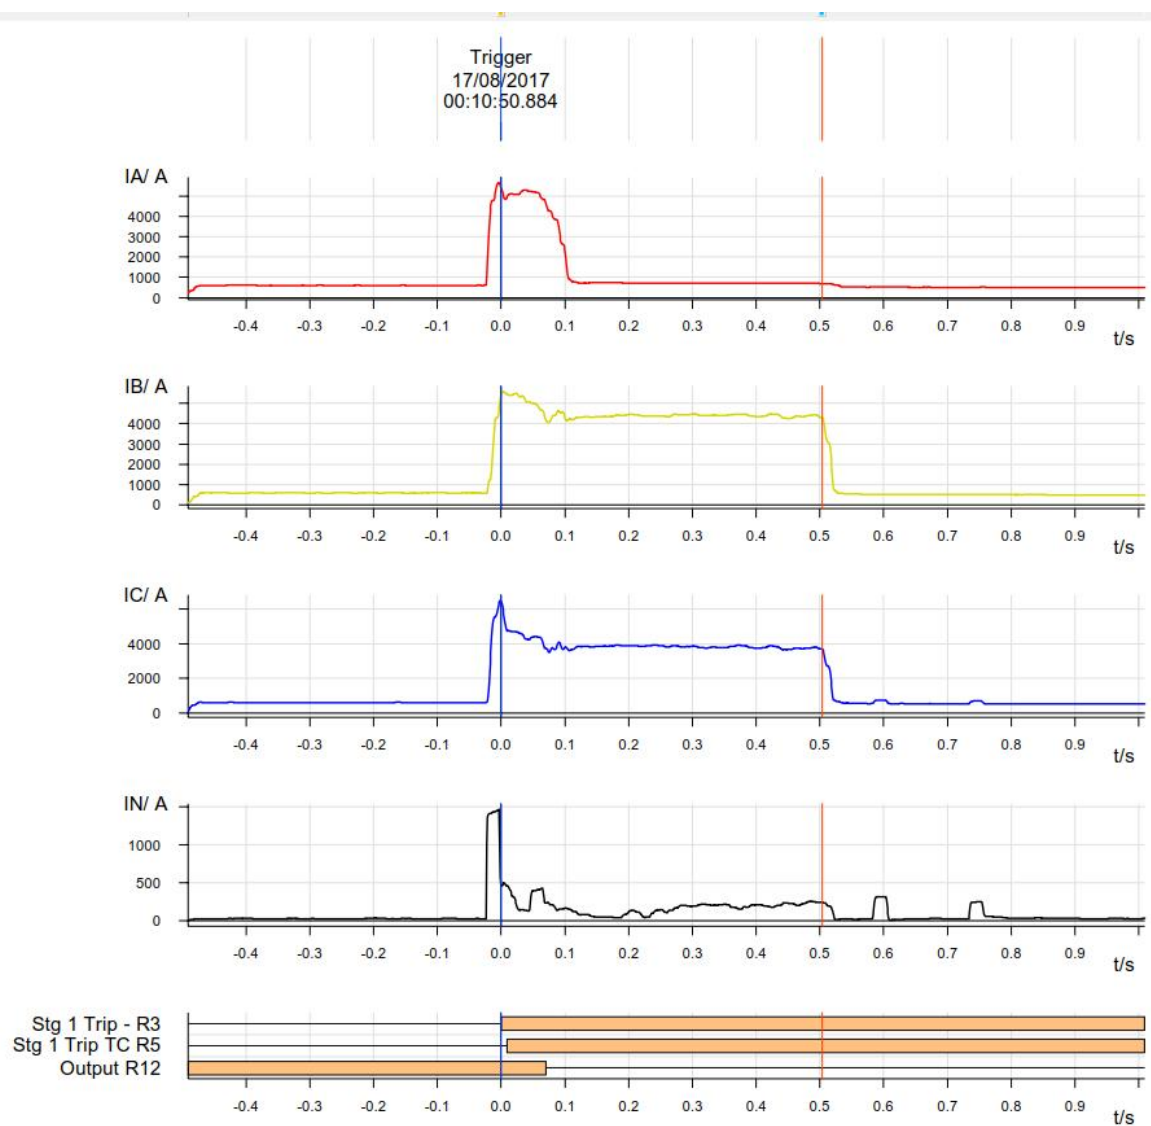
**Figure 4-2: RMS Adaptive Protection Relay Recordings
(IA=red, IB=yellow, IC=blue and IN(residual)=black)**

The Adaptive Protection relay disturbance recorder, recorded a total fault duration of 0.525 secs i.e. the time from fault initiation to opening of the F3145 Tramway Rd 6.6 kV feeder circuit breaker to clear the fault.

The total fault clearance times obtained from the disturbance record of the Adaptive Protection relay and from the CRMS event-log are not in line with the above calculated operating time of the F3145 Tramway Rd 6.6 kV feeder overcurrent protection. It is possible that settings recorded on the setting sheet may not be the as-installed settings. The actual settings should be confirmed on site.
