RESPOND POST FAULT ANALYSIS

REPORT N^O 62104988

Electricity North West Ltd

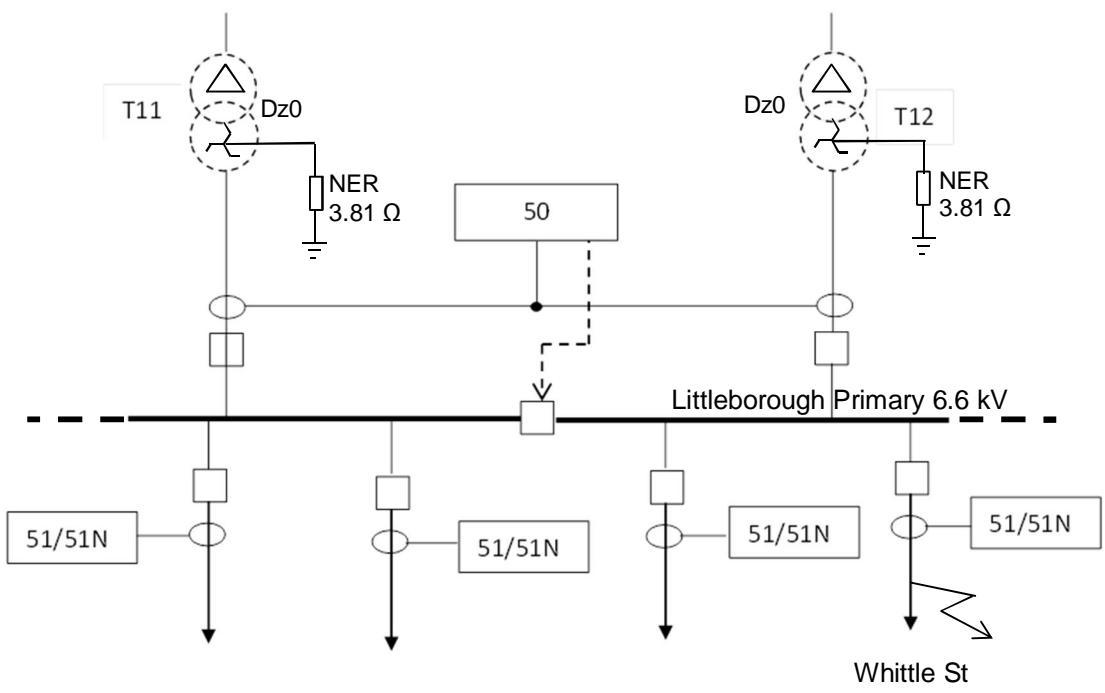
Figure 3-1: Littleborough Primary Substation Network

The pre-fault Littleborough Primary network configuration is shown in Figure 3-1. For the Respond trials, the 6.6 kV transformer incomer CTs are connected in parallel. The individual phase current inputs to the Adaptive Protection high-set instantaneous overcurrent relay (50) receives the sum of the respective phase currents in each transformer incomer. Operation of the Adaptive Protection initiates the tripping of the 6.6 kV bus section circuit breaker, increasing the impedance to the fault and reducing the initial fault current.

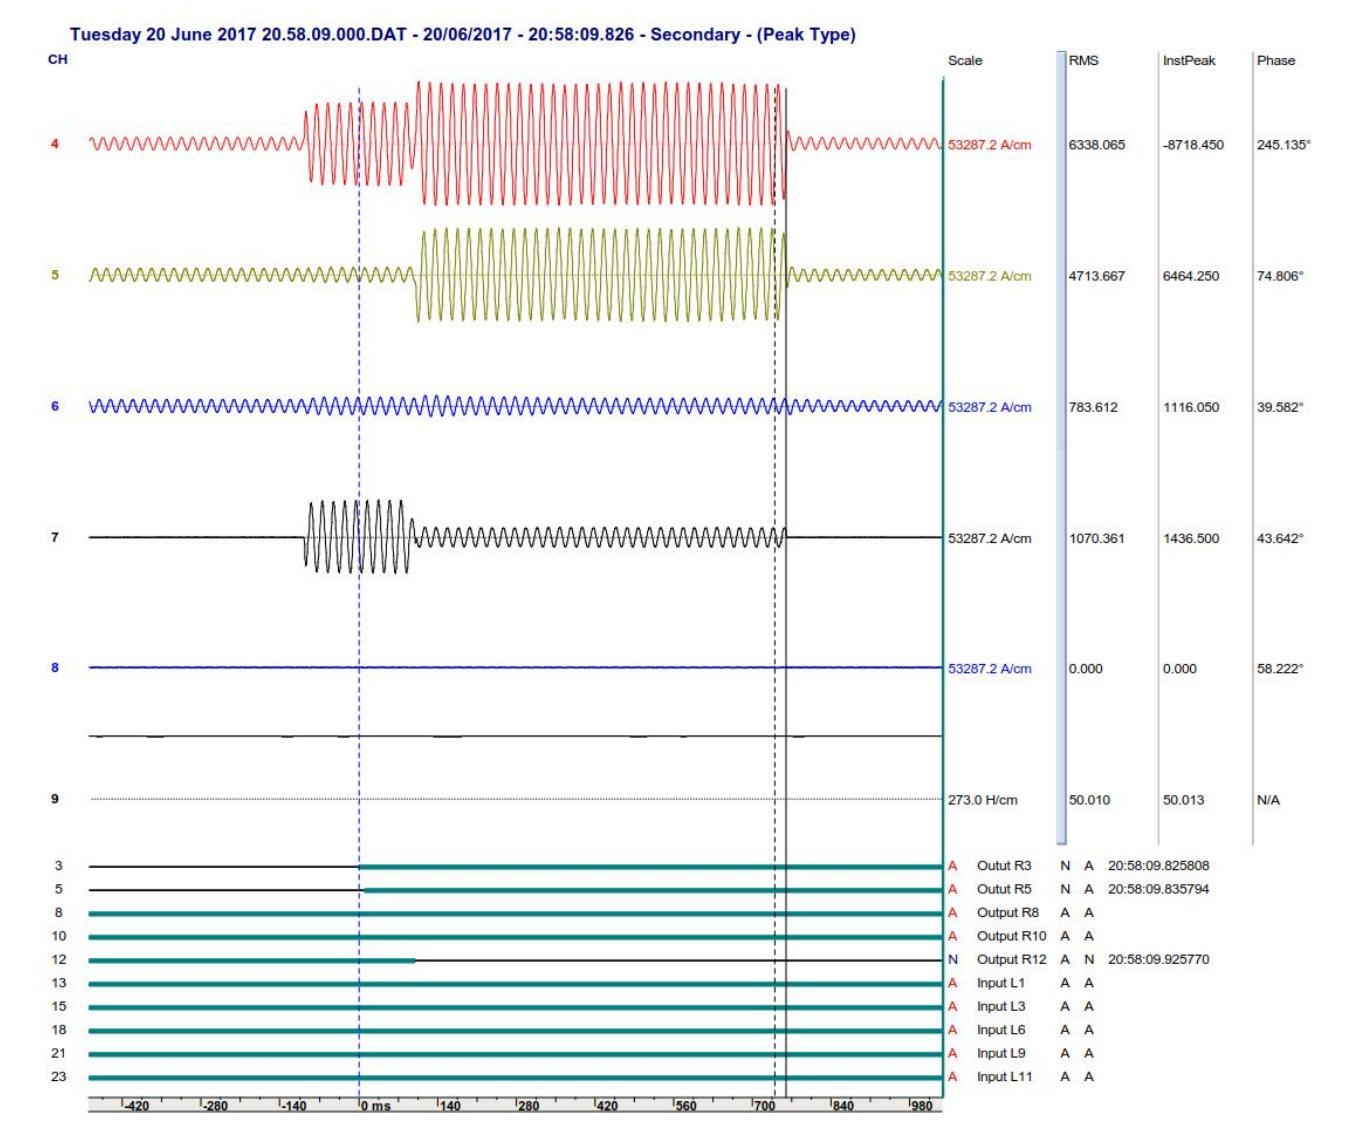
Figure 4-1: Instantaneous Adaptive Protection Relay Recordings (IA=red, IB=yellow, IC=blue and IN(residual)=black)

The instantaneous and RMS disturbance records obtained from the Adaptive Protection relay are shown in Figure 4-1 and Figure 4-2 respectively.

In these figures, Output R3 is the trip signal from the Adaptive Protection Stage 1 to the 6.6 kV bus section circuit breaker and output R12 is the bus section circuit breaker "a" auxiliary contact repeat signal to telecontrol.

The disturbance records show that the Adaptive Protection responded to a red phase to earth fault. The magnitude of the fault currents inclusive of load current were 4575 A, 769.1 A and 913.7 A in the red, yellow and blue phases respectively. The measured residual fault current was 4024 A.

The phase to earth fault was present for 100 ms before the Adaptive Protection was triggered. In this case the fault current was only a multiple of 1.01 times the Adaptive Protection I>3 current setting. For fault currents greater than a multiple of 2 times the current settings, the detection time should be less.

The 6.6 kV bus section circuit breaker tripped 99.8 ms after the trip signal from the Adaptive Protection relay was sent. This time is largely dependent on the circuit breaker operating time and would not change with fault current.

After the 6.6 kV bus section circuit breaker tripped, the fault developed into a red phase to yellow phase to earth fault with 6734.7 A in the red phase, 5056.7 A in the yellow phase and 949 A in the blue phase with a residual current of 1048.1 A.

In order to capture the opening of feeder circuit breakers with longer protection operating times, it is recommended that the total recording time is increased to 2.0 secs with the same pre-trigger recording time of 0.5 secs. The recommended relay setting parameters are as follows:

Duration = 2.0 secs

Trigger Position = 25 (%)
