Oil regeneration

Electricity North West has pioneered a new, environmentally friendly approach to regenerating oil which extends the life of our power equipment and keeps costs down for customers across the region.

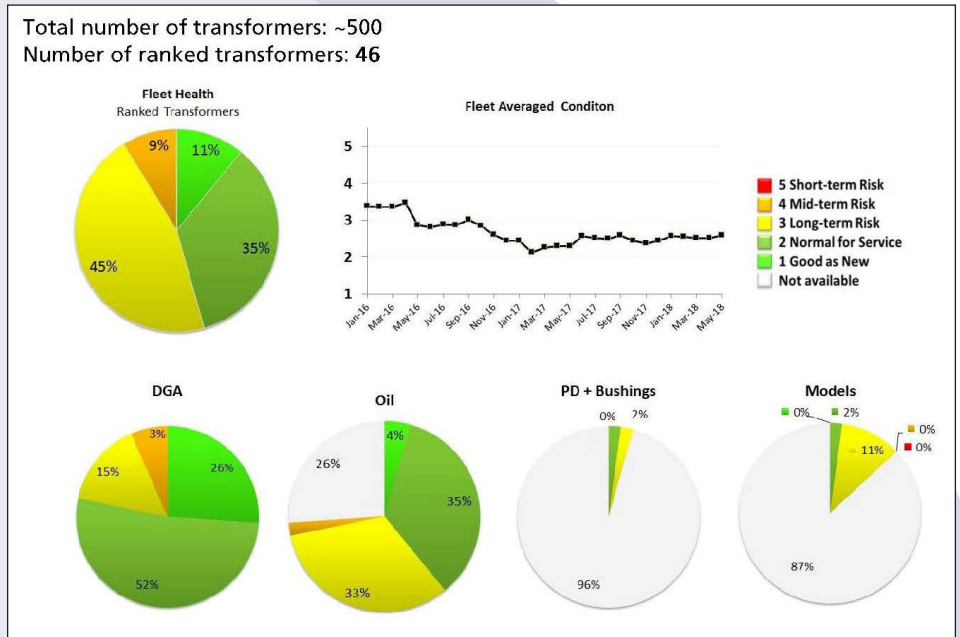
Figure 4: Fleet overview

To help with the data analysis we have developed a visualisation tool which produces reports on the condition of our transformers. This report consists of high level red, amber and green status management reporting and provides the ability to analyse more in-depth data. The reports can provide a transformer fleet overview, a high level short-term action check list, a summary of fleet condition and exception reporting, and site specific details.
